Using CFRP for Shear Strengthening of Continuous SCC Hollow Beams Containing Transverse Internal Ribs

Ali Hameed Aziz Ph.D (Asst.Prof.)* Ashraf A. Alfeehan Ph.D (Asst.Prof.)* awaz Adel Hussain(Lecturer)*

The present paper is devoted to investigate, experimentally, the shear strength of continuous self-compacting concrete hollow beams containing internal concrete ribs and externally strengthened by strips of carbon fiber reinforced polymer (CFRP). Six full-scale beam specimens were cast and tested. The adopted variables in this study are the number of internal concrete ribs and U-shape external CFRP strips. Experimental results show that the shear failure was the dominant failure for all the tested beams. The cracking and ultimate loads are reduced by about (19.6 and 30.6%) for the hollow beam specimens which contains, five and three ribs respectively, compared with the reference beam. The ultimate load was increased by about (19.13%) for the solid beams strengthened by CFRP strips compared with the solid beam without strengthening. The ultimate load was increased by about (39%) for five internal ribs hollow beams strengthened by CFRP strips compared with the same beams but withou

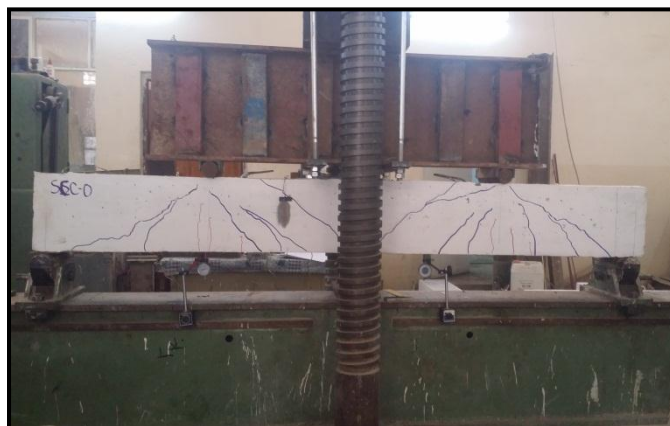
The beam specimens were tested at age of (28 days), where they were prepared by cleaning and painting them with white color, in order to detect the propagation of cracks. The beam specimens were placed on the testing machine with clear spans of (1210mm). Dial gauges were placed in their locations at mid span (at 605mm from the support) and quarter span (at 302.5mm from the middle support). The strain gauges were connected with a data logger (TML/ TC-32K). All beams were tested under monotonic loading, up to failure, with single concentrated load applied at the mid-span of each span of beams as shown in Figure (10).

Figure (10) Beam Specimen Setup

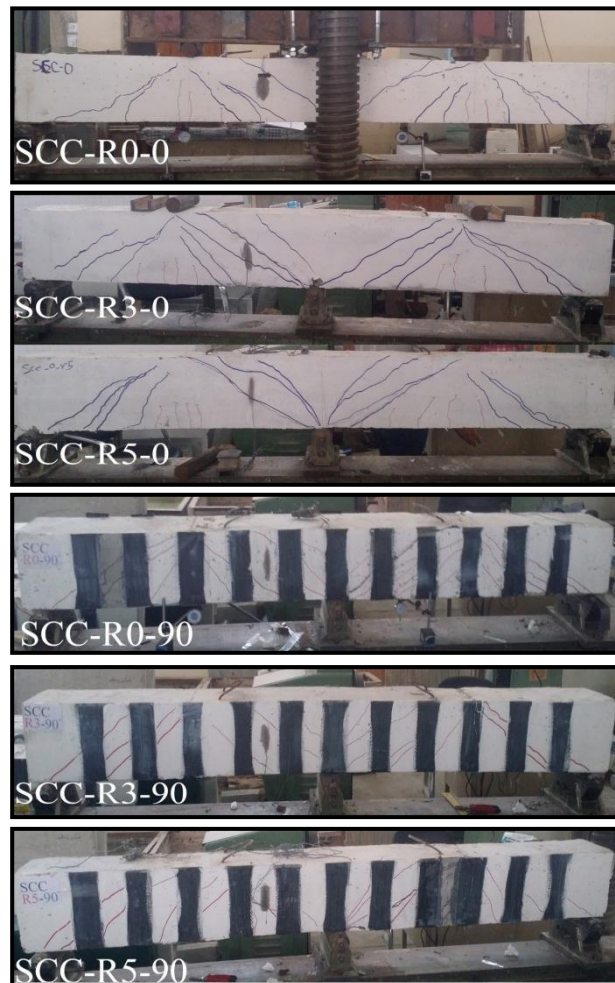
At early stages of loading, several cracks initiated near the middle support (at maximum shear), with further loading, these cracks appeared near the support edge and extended upwards, toward the load point, and became wider in shear spans. One or more cracks propagated faster than the others and reached the compression flange (near applied load), where crushing of the concrete near the positions of applied loads had occurred due to high concentrated stresses under load, Figure (11).

Figure (11) Crack Pattern

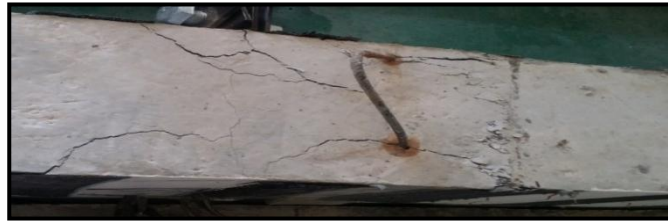
Before failure of the beam specimens with warping U-shape CFRP, longitudinal cracks form on the top surface of the specimens. The crack initiated close to the position of applied load and extended towards the middle support as shown in Figure (13).

Figure (13) Cracks on the Top Surface of Beam Specimens

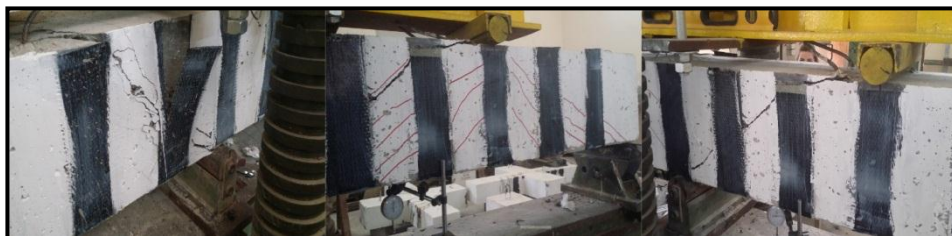
Figure (14): Debonding of CFRP for Beam Specimen (SCC-R0-90°)

(SCC-R3-00), this may be due to increasing of the number of internal ribs, which led to increasing the total volume of concrete; and the position of two internal ribs under the load(at mid span) cause this higher level. The influence of CFRP was clear in both, load and mode of failure. The beam specimen (SCC-R0-90°) failed at load of (1090 kN) and this is greater than by about (19.13%) compared with the reference. This may be due to high contribution of the CFRP, and as a result, the beam specimen failed due to CFRP debonding as shown in Figure (14).

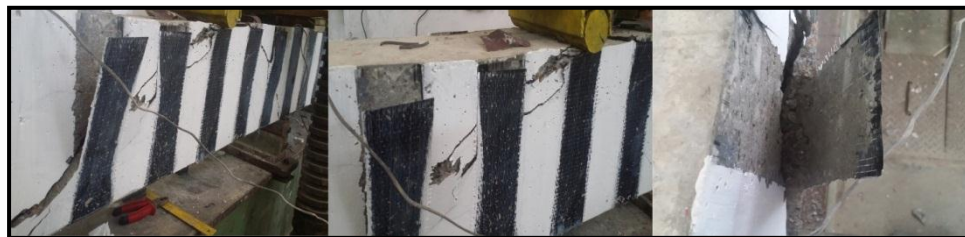
Figure (15): Debonding of CFRP for Beam Specimen (SCC-R3-90°)

The ultimate load for beam specimen (SCC-R3-90°) was (810 kN) and the mode of failure was CFRP debonding as shown in Figure (15). It may be noted that, the ultimate load of beam specimen (SCC-R3-90°) was decreased by about (11.48%) in comparison with the reference beam. This means that the CFRP strengthening reduces the damage of hollow beams but doesn't reach to the ultimate load of reference beam like the beams of five internal ribs. The gains in ultimate load due to strengthening by CFRP when compared beam specimen (SCC-R3-90°) with (SCC-R3-00) was (27.55%). The ultimate load for beam specimen (SCC-R5-90°) was (1022.5 kN) and the mode of failure was CFRP rupture as shown in Figure (16), The increase in ultimate load of the beam specimens (SCC-R5-90°) was (11.75%) in comparison with the reference beam. The increase of the ultimate load for the beam specimens (SCC-R5-90°) was (39%) in comparison with the beam specimen (SCC-R5-00). Clearly, this may be due to the contribution of strengthening by CFRP.

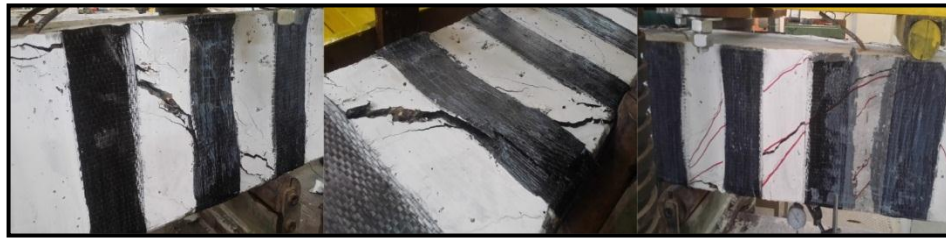
Figure (16): CFRP Rupture for Beam Specimen (SCC-R5-90°)
